# G.V. ABSORBER F-3303

A Case Study on failure due to corrosion on shell.

By R. K. Sharma

IFFCO Aonla

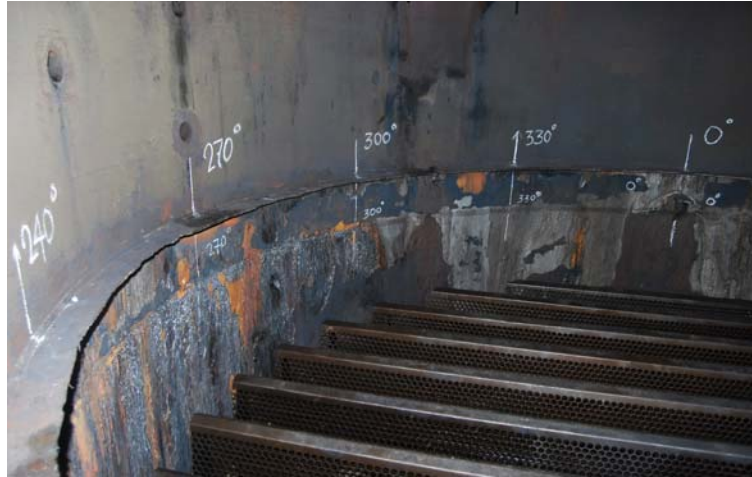
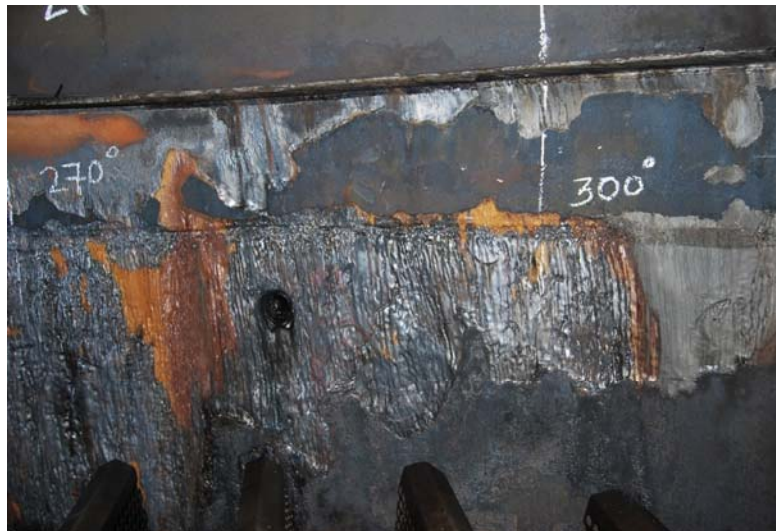
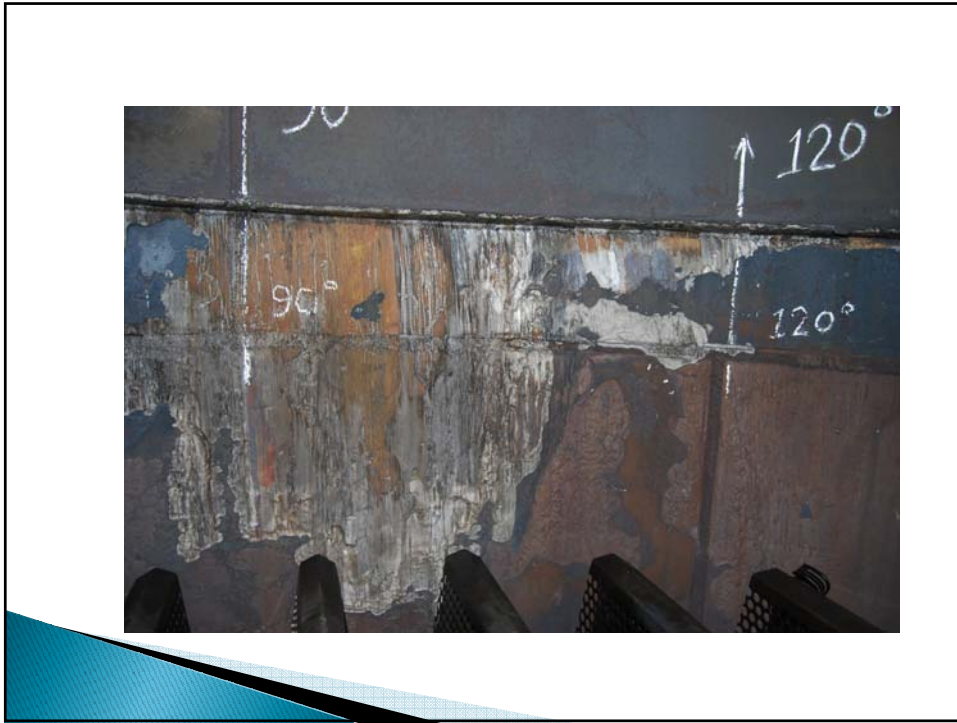
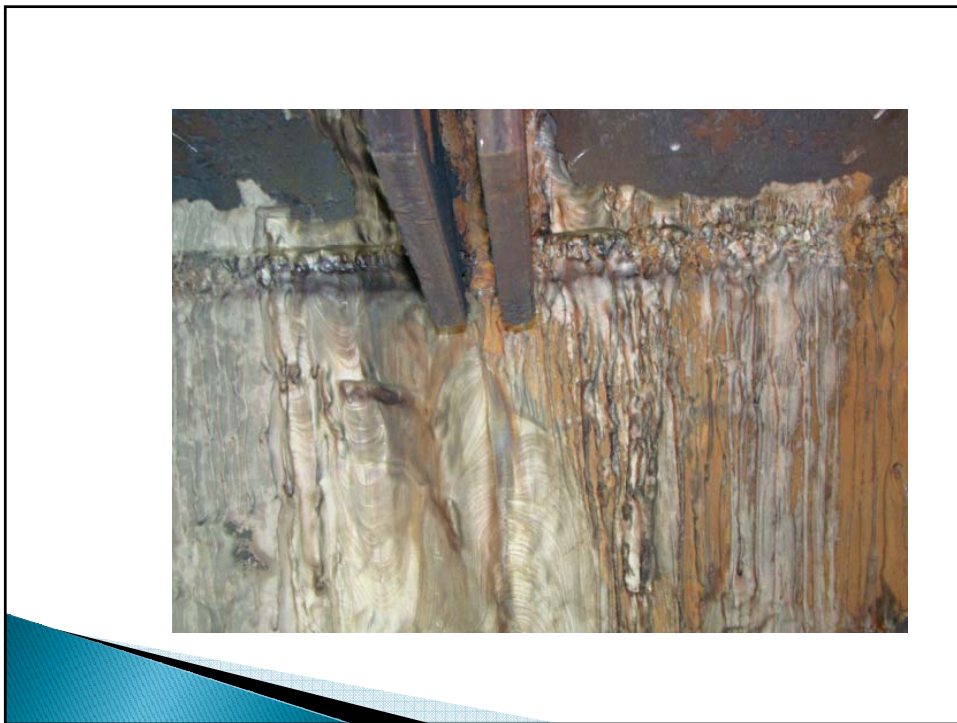
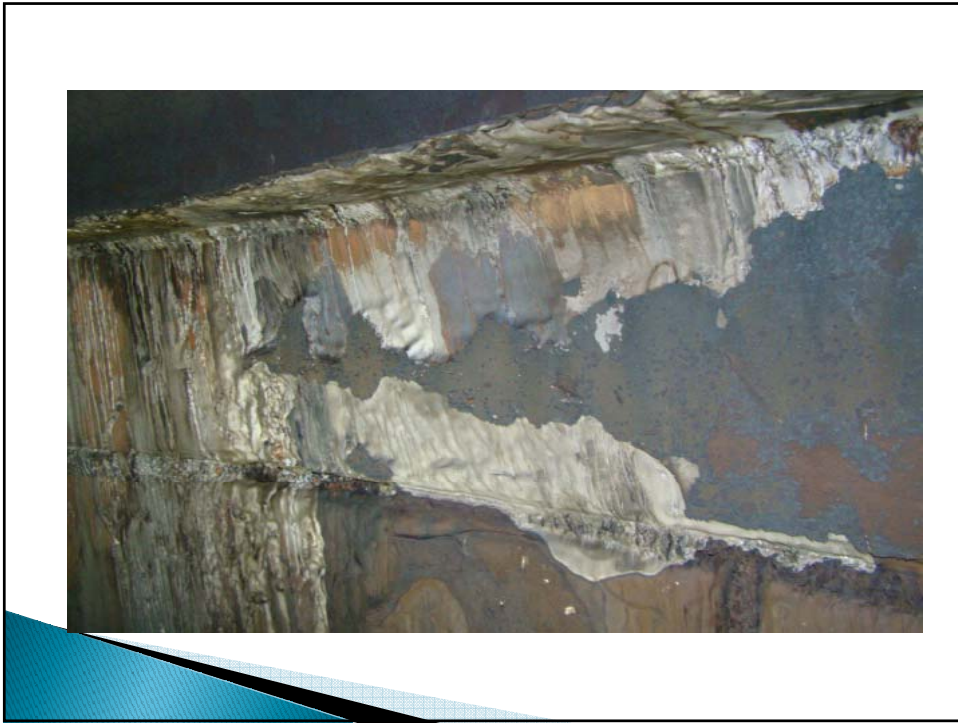
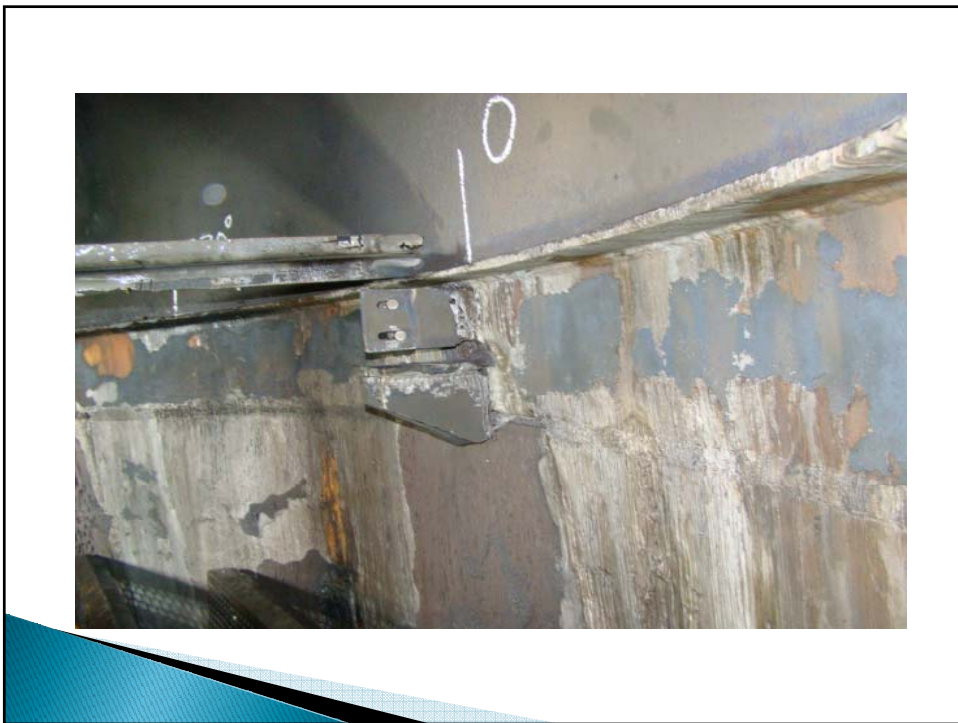
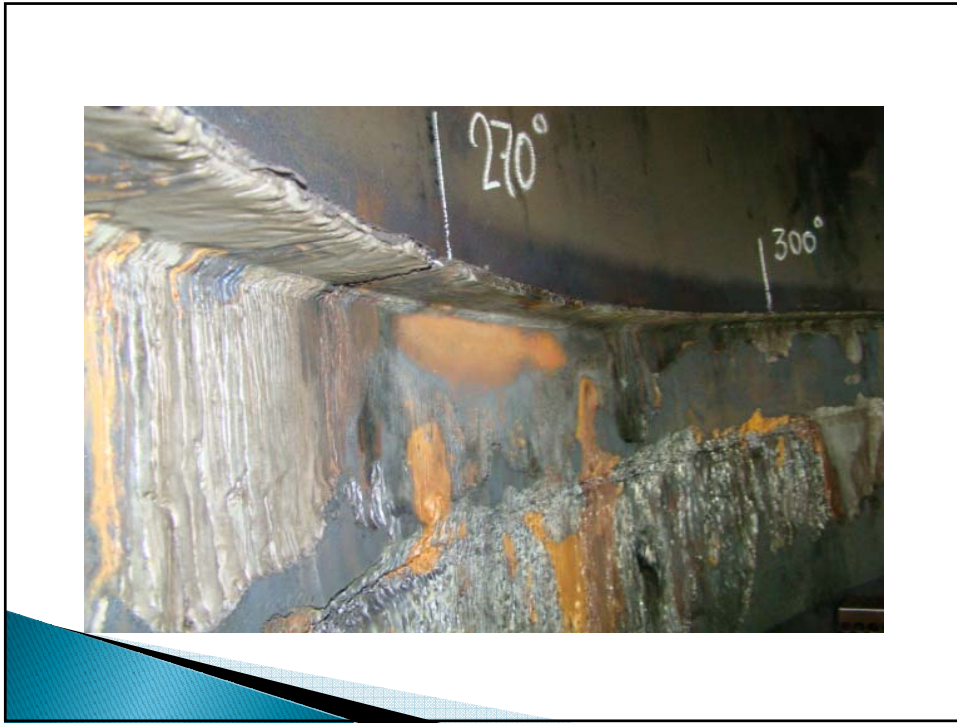
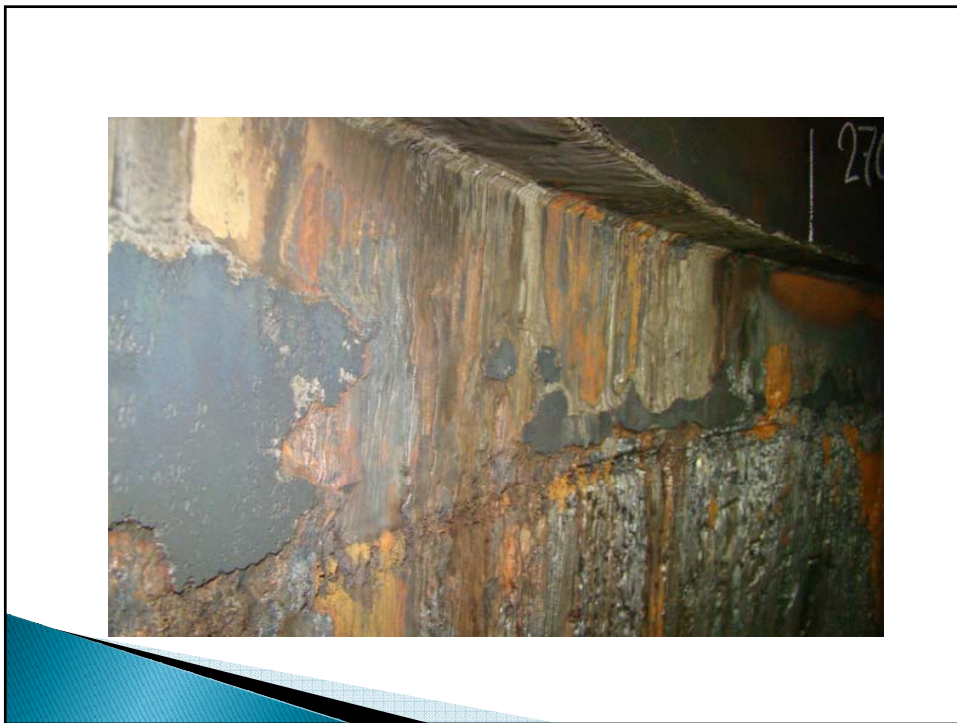
- ▶ A through hole was observed in 'C' seam in front of manhole M-5 (towards west side) between 105° to 110°. 0° has reference opposite to DM plant i.e. north side and degree clockwise increases. Erosion had been found at many places on 'C' seam. One meter height of shell area in complete circumference between both trays supporting ring (TSR) was found badly corroded/eroded. There were many notches & canals of varying depth of 5-15 mm over the entire circumference of shell between trays supporting rings (TSR). Both trays supporting rings (TSR) were found badly corroded. I-beam and brackets to support omega tray were also found badly corroded.

**PHOTOGRAPHS OF CIC. SEAM & AFFECTED SHELL AREA IN SIDE M5 MANHOLE.**

- ▶ Entire C seam was grinded and 'V' had been made in the leaky area. Preheat temperature of C seam was raised up to 150° c by electrical heating pads. The affected area where through hole was there was repaired by TIG welding using ER-70S filler wire while other part of C seam was repaired by Arc welding using E-7018-1 electrode. C seam was post heated by raising the temperature up to 250°c by electrical heating pads, thereafter soaking for of 1 hr. at 250° C and then cooling up to 150° C. All the heating coils had been removed at 150°c.
- ▶ Apart from this C seam, all the patches of affected areas were grounded properly before starting the welding repair work on inner surface of the shell.
- ▶ It was decided to build the shell thickness up to 40 mm. wherever shell thickness was found less than 40 mm, it was built up to 40 mm by arc welding using electrode E-7018-1.

- - ▶ For welding repair of the affected areas of main shell, preheating was done by using five gas burners over the surface area of marked 7 patches and temperature was raised up to 150°C. First filling of notches and canals was done by welding and then material built up is done for raising the thickness of the affected areas.

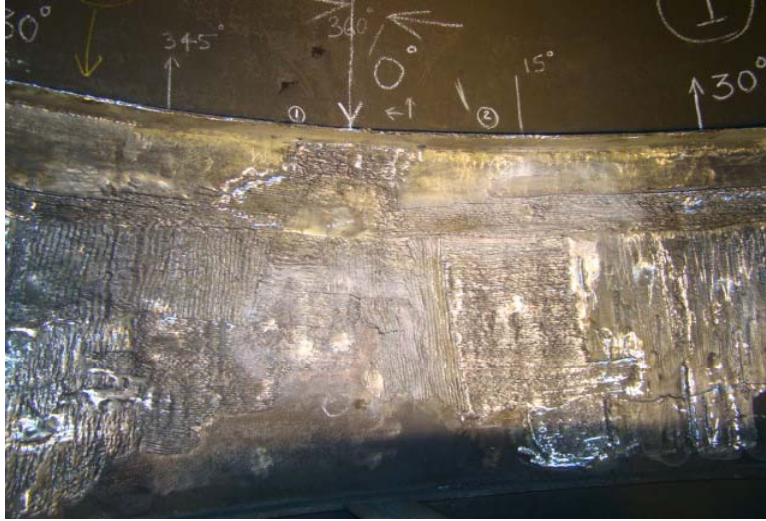
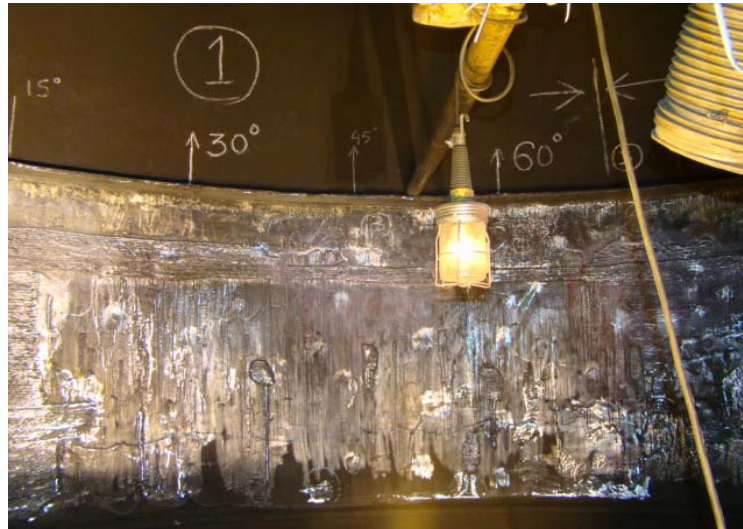
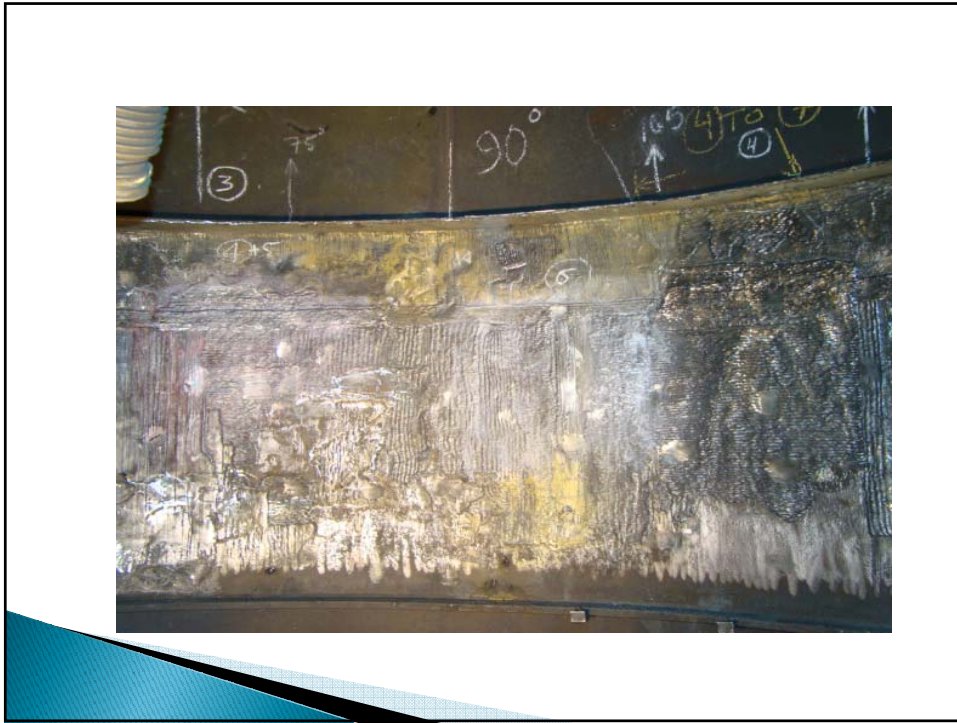
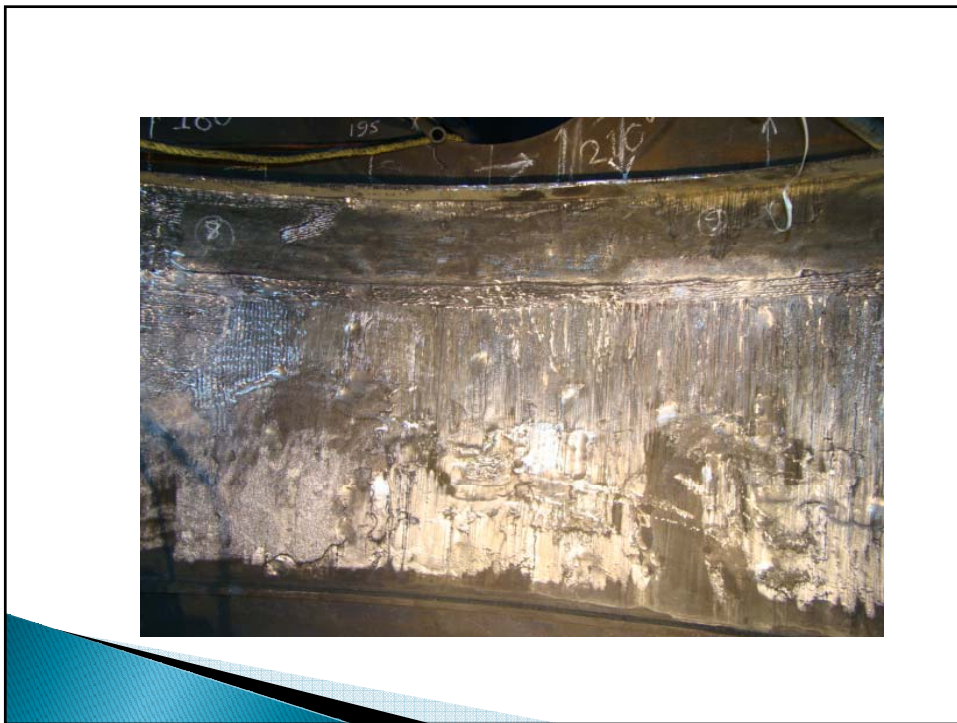
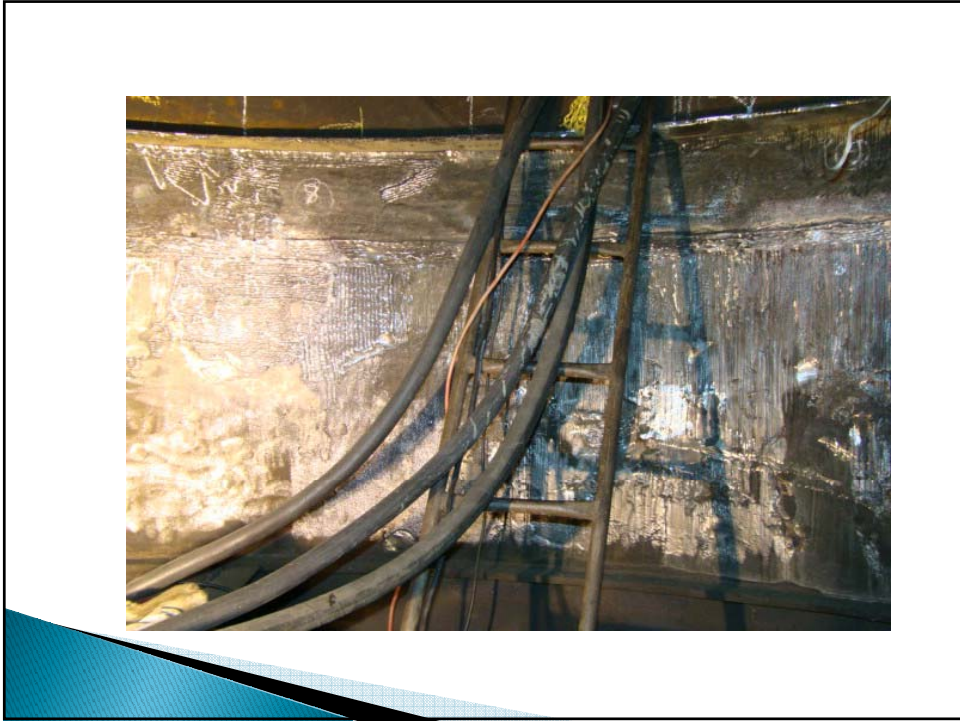
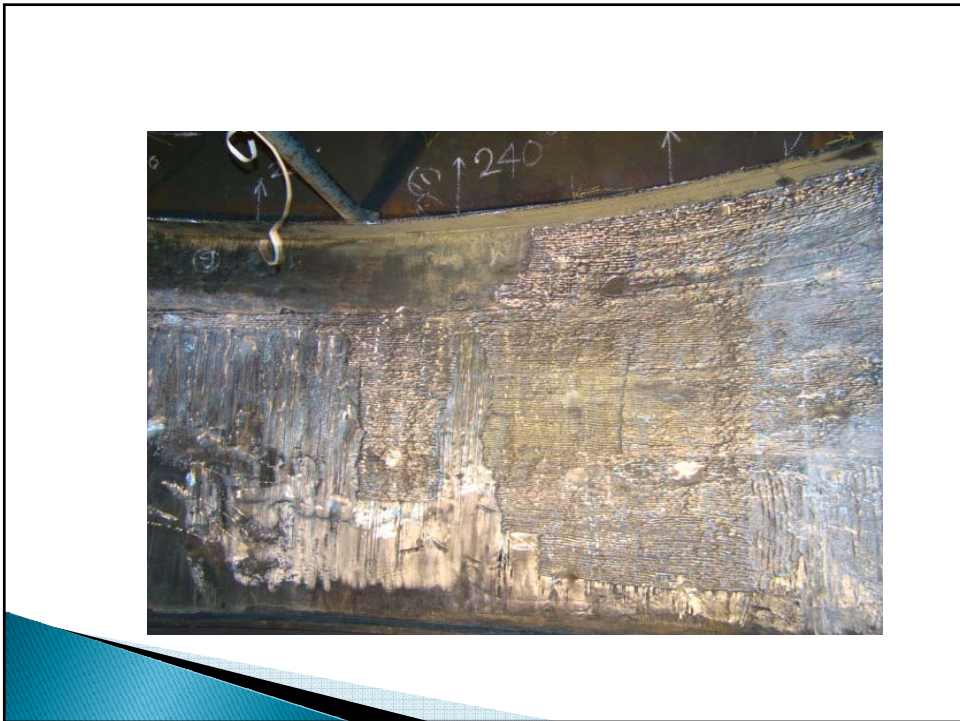
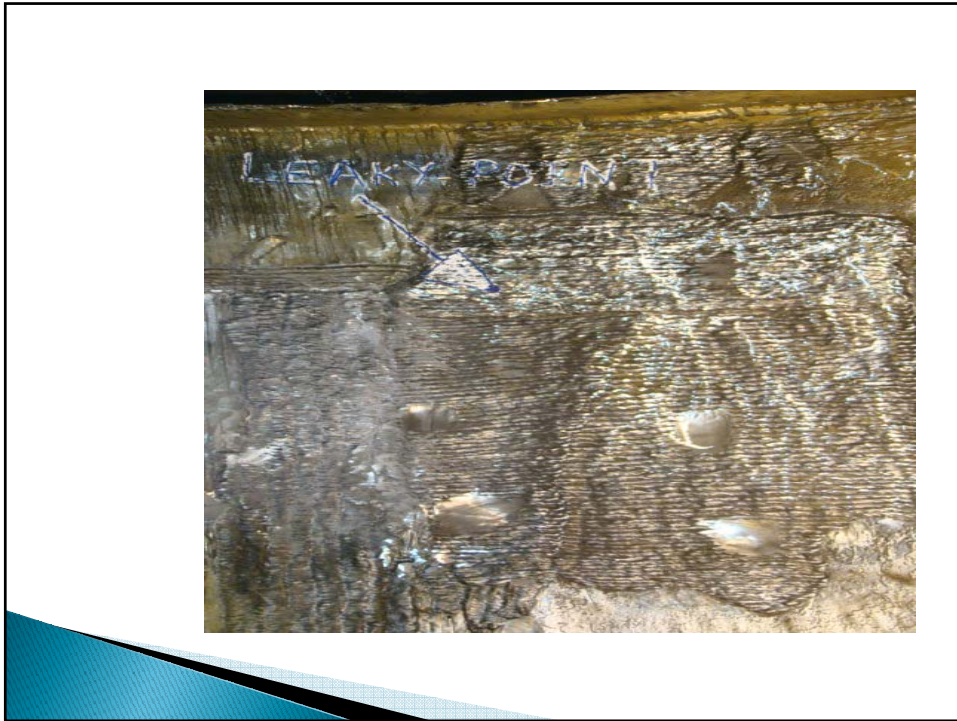
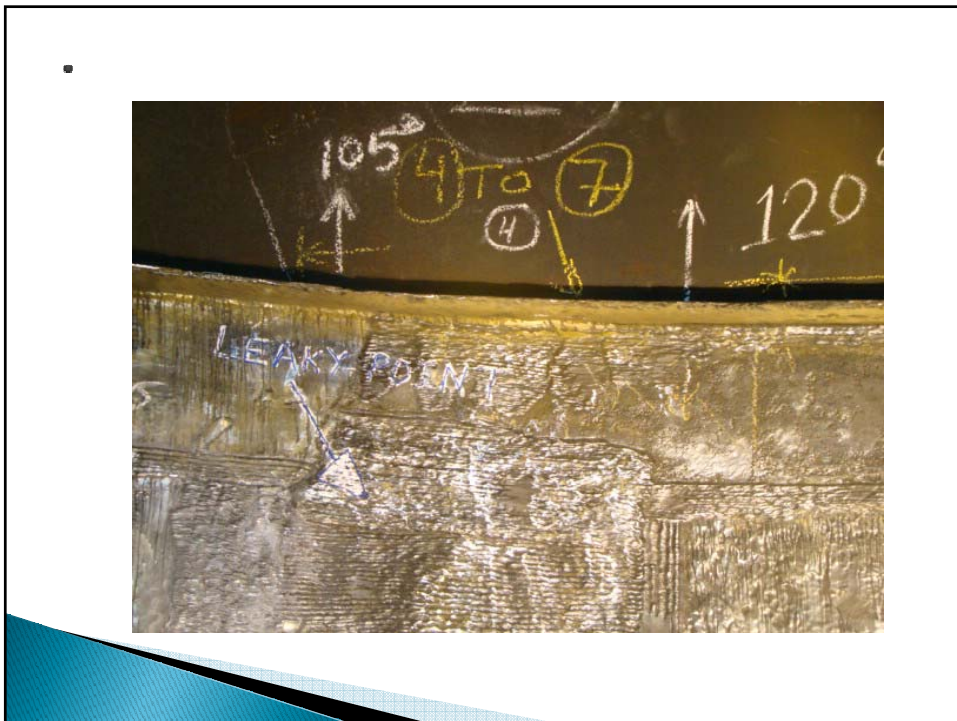
- ▶ Thickness & hardness measurement of entire affected area was carried out all around 360° locations by preparing grids 7½ ° apart at minimum 5 locations vertically between TSRs on 10/09/10. Thickness measured at leakage area was found 50 mm. Thickness was found 40.2 mm to 51.00 mm in all places between TSRs.
- ▶ Hardness found near leakage was 139 BHN whereas hardness of the rest of the locations was found well within the limit.
- ▶ UT test was also carried out. No abnormality was found.

## PHOTOGRAPHS AFTER REPAIR:
