# G.V. ABSORBER F-3303

A Case Study on failure due to corrosion on shell.

By R. K. Sharma

IFFCO Aonla

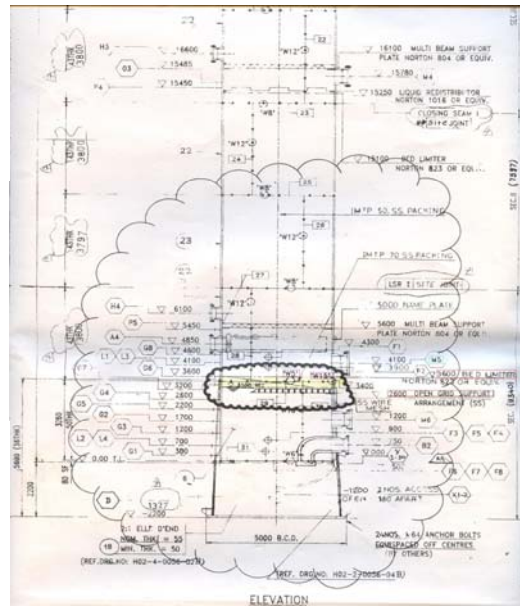
## Drawing:

- ▶ A heavy gas leakage sound was observed at 11.45AM on 3/09/2010 from inside the vessel skirt. The exact location of the leakage could not be known immediately because the leakage was from C-seam joint which is just below the vessel to skirt joint inside the skirt.

- ▶ It was decided to stop the plant and open the absorber after proper purging of the vessel. In the mean while, to know the exact position of the leakage from outside, a window was cut on skirt of size 12"X 18" towards west side where some crystal deposits of GV solution in between skirt & pressure shell of absorber F-3303 was observed. But no leak was found there. After purging of the vessel by connecting vacuum blower at M1 and M6 manhole and running it for 12 hrs, the M5 manhole was opened for inspection and leaky area detection from inside. After opening the Manhole M5, the bed limiter was found in broken condition and it was observed to be lifted up from east side because of shifting of the entire pickings on that side. The complete bed ( bed limiter, Tower Packing (IMTP 70) and grid support trays) was removed to approach the damaged shell area.
